# Effect of corrosion on the mechanical properties of the corroded reinforcement and the residual structural performance of the corroded beams

Wenjun Zhu. Effect of corrosion on the mechanical properties of the corroded reinforcement and the residual structural performance of the corroded beams. Civil Engineering. INSA de Toulouse, 2014. English. NNT : 2014ISAT0013 . tel-01222175

Effet de la corrosion sur les propriétés mécaniques de l'armature corrodée et la performance structurale résiduelle des poutres corrodées

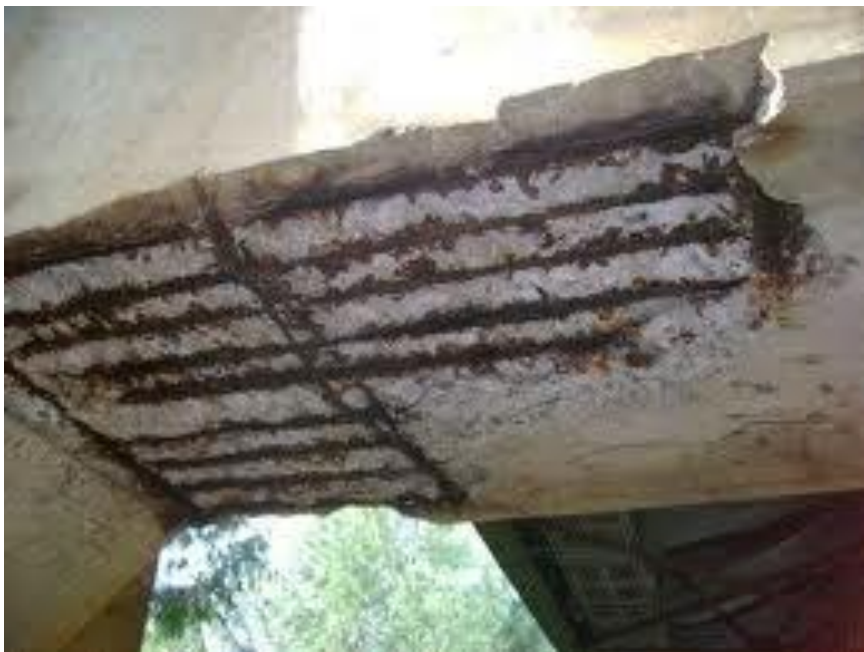
Le béton est sans doute la meilleure protection de l'acier vis-à-vis de la corrosion en raison du pH élevé de sa solution interstitielle présente dans la porosité. Cependant, il existe deux causes principales d'amorçage de la corrosion : la diminution du pH de la solution interstitielle due à la carbonatation (réaction du gaz carbonique avec les hydrates du béton conduisant à la formation d'un acide faible) qui permet la corrosion de l'acier, ou rupture local du film passif recouvrant l'acier en raison de la présence d'un taux minimum d'ions chlore (figure 1).

Figure 1 : corrosion de l'acier
